# Manhole Inspection Summary

Manhole # S15A\_\_007MH

Insp Date: **5/6/09 9:26 AM**

**Location** Address: **INTER- RAYNOR**

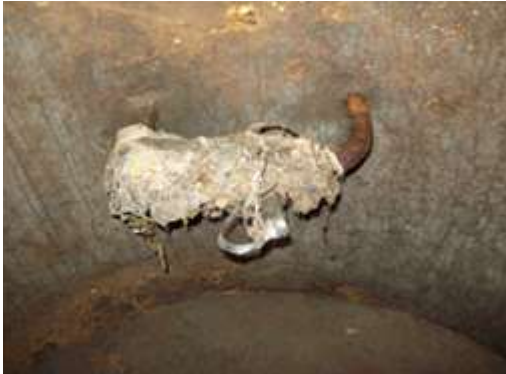
Defect 1

EVIDENCE OF SURCHARGE

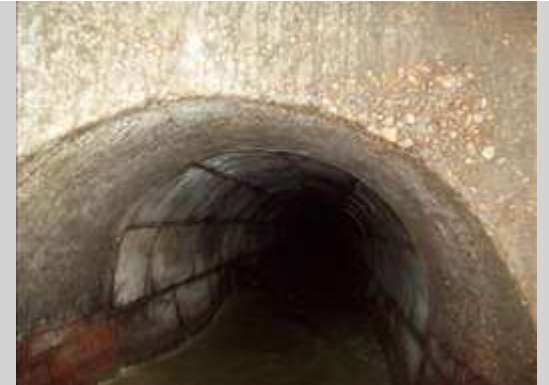
12 O'Clock Outflow

33 in. Circular Gravity Sewer  
Pipe Out @ 12 O'Clock

Pipe Height: **30** (in.) Rod and Bar  
Pipe Material: **Unknown** ☐ Pipe Lined  
Invert Depth: **17.45** (ft.) Flow Characteristics: **Fast**  
Deposits: ☒ None ☐ Mud ☐ Sludge ☐ **Debris** ☐ Grease  
Silt Depth: (in.) Deposits Extent:  
Infiltration: **None** Pipe Seal Cond: **Sound**

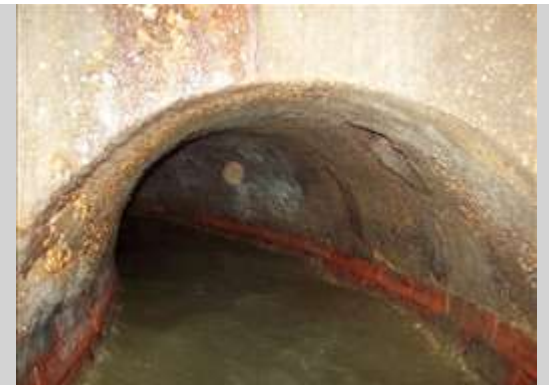
6 O'Clock Inflow

33 in. Circular Gravity Sewer  
Pipe In @ 6 O'Clock

Pipe Height: (in.) Direct  
Pipe Material: **Unknown** ☐ Pipe Lined  
Invert Depth: **17.18** (ft.) Flow Characteristics: **Fast**  
Deposits: ☒ None ☐ Mud ☐ Sludge ☐ **Debris** ☐ Grease  
Silt Depth: (in.) Deposits Extent:  
Infiltration: **None** Pipe Seal Cond: **Sound**

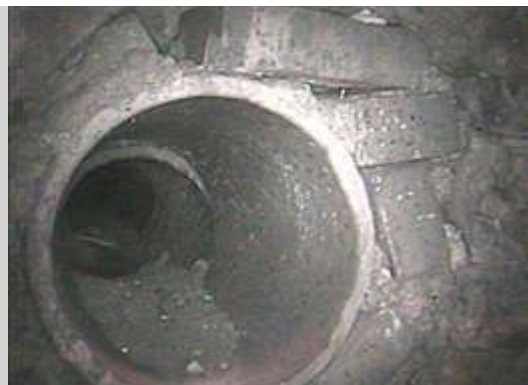
7 O'Clock Inflow

12 in. Circular Gravity Sewer  
Pipe In @ 7 O'Clock

Deposits: ☐ None ☐ Mud ☐ Sludge ☒ **Debris** ☐ Grease

Silt Depth: **2** (in.) Deposits Extent: **Light**

Infiltration: **None** Pipe Seal Cond: **Broken**
